Belzona Protects Tank Roof against Sulphur Fumes

ID: 8154

Repair of a Sulphur tank roof.

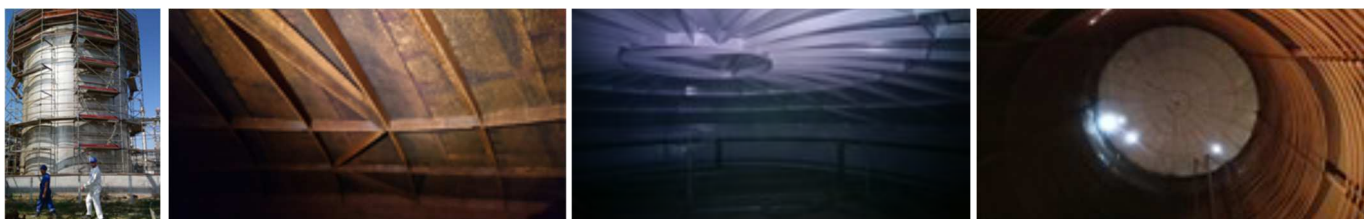
Photograph Descriptions

A build-up of condensation from the 100 % liquid Sulphur had caused the tank roof to pit and corrode.

1. Outside view of the Sulphur tank
2. Corroded tank roof
3. 2 coat system of Belzona® 1593 applied to the roof
4. View of the tank roof from the bottom

This application was carried out in accordance with Instructions for use. The tank roof was cleaned and then grit blasted to SA 2,5, achieving a 75 microns profile to provide an excellent level of adhesion to the substrate. Once grit blasted, any pits were filled in with Belzona® 1511 before 2 coats of Belzona® 1593 were applied to the tank roof.
