Wear Plates in Rolling Mill Secured with Belzona

ID: 7620

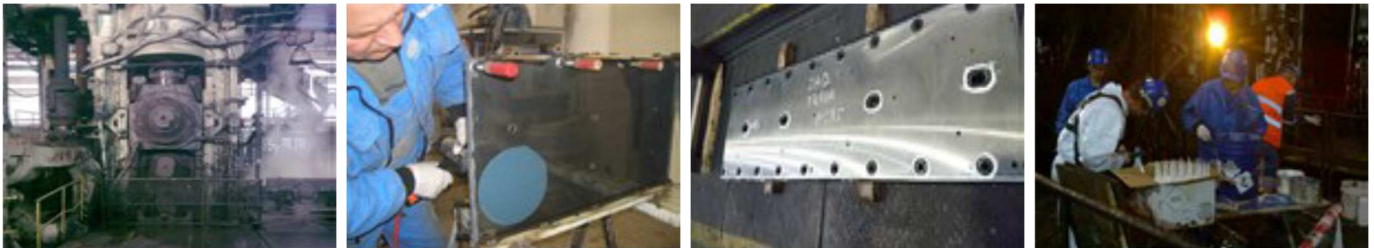
Photograph Descriptions

An irregular shim is required to secure the wear plates once levelled and bolted in place.

1. The Rolling Mill
2. Testing of the Belzona® 1321 injection
3. Wear plate
4. Belzona 1321® injection in action

Wear plates have to be adjusted, tightened and then Belzona® 1321 injected to create irregular shim between plate and mill frame. This is a routine application for Belzona® 1321 which demonstrates excellent compressive strength required for this application.
