Belzona Repairs Concrete Footing

ID: 7564

Industry: *Building & Structures*
Application: *TCC-Tanks and Chemical Containment Areas*
Substrate: *Concrete and Steel Reinforcement*
Products: *Belzona® 4111 (Magma Quartz)*

Customer Location: *Construction company, Slovakia*
Application Date: *2006*

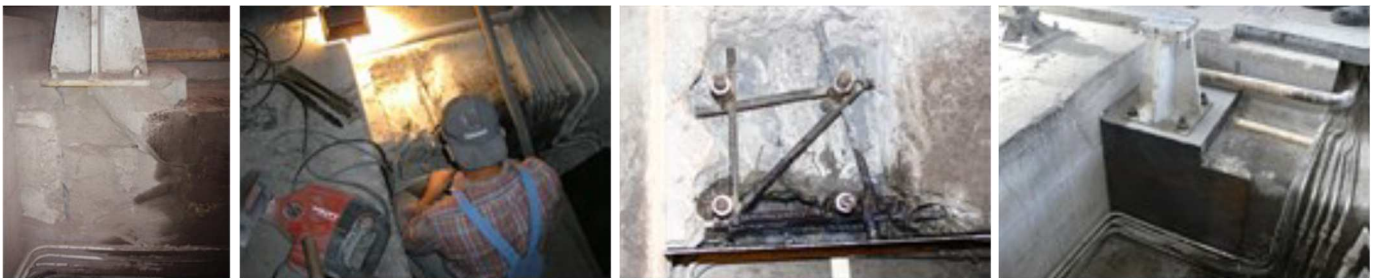
Photograph Descriptions

The footing was damaged by impact, this caused instability on the machine which meant it could not be used.

1. Destroyed concrete footing
2. Belzona® 4911 (TX Conditioner) application
3. Repair in progress
4. Belzona® 4111 used to rebuild the base

The concrete footing of a cutting machine in a large workshop.

The Belzona concrete repair allowed the machinery to be back online in only 4 days, compared to the possible 28 days cure time for concrete. The Belzona materials also have greater impact resistance to protect from future damage.
