Bed Plate of Pressing Machine Rebuilt with Belzona

ID: 7594

Industry: General Industry
Application: ENC-Engines and Casings
Substrate: Steel
Products: Belzona® 1111 (Super Metal)

Customer Location: Rubber producer, Slovakia
Application Date: 2013, 2014

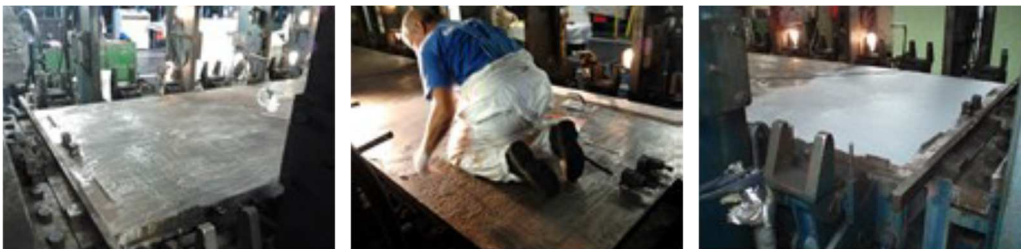
Hydrochloric acid condensed from the process destroyed the base plate of the pressing machine.

1. Surface preparation
2. Belzona® 1111 being applied
3. The plate ready for leveling by grinding

Application was carried out in accordance with Instructions for use. After Belzona® 1111 application it was necessary to level the plate by grinding.

Welding of this damage would take a long time, so rebuilding with Belzona® 1111 was much better for customer. It was not first repair like this, first repair was done in 2013 and customer was satisfied with the outcome.
